## Dynamic Slip Resistance using ASTM E303-93 (2018) Pendulum Test Method per ASTM F2772-11

Client: North Kitsap School District

Report date: 11/22/19

Flooring: Wooden gym floor and concrete hallway at N. Kitsap High School Main Gym

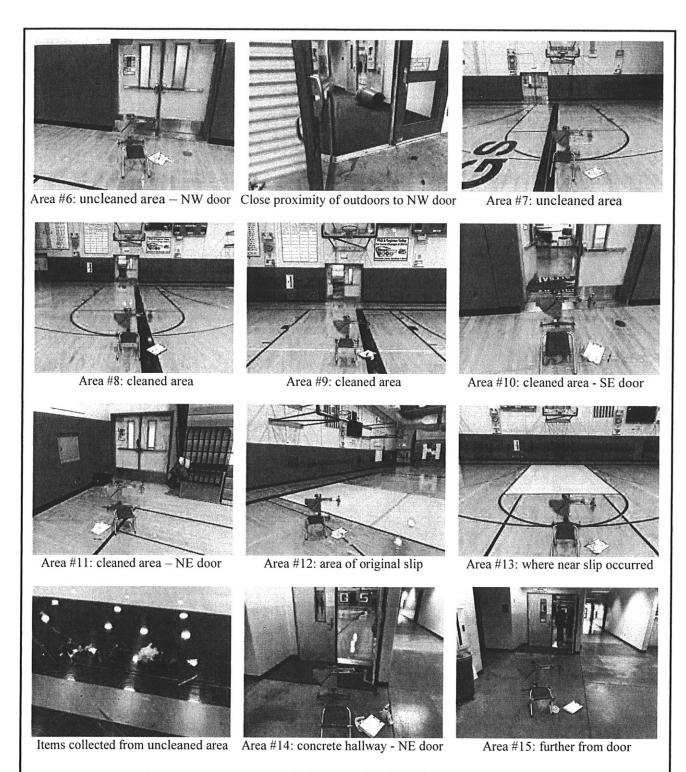
Figure 1: general areas and close-ups of polished concrete areas tested

Area #1: cleaned area

Area #2: uncleaned area

Area #3: uncleaned area

Area #4: uncleaned area

Area #5: uncleaned area - SW door

Inadequate matting outside SW door

All the coated wood gym floor areas tested were within the 80-110 PTV range specified by ASTM F2772-11 when tested in the dry condition, even the areas that hadn't been cleaned for many days. However, the uncleaned half of the gym had collected quite a bit of visible contamination, such as fine dust, dead flies, and what appeared to possibly be either lint from socks or tiny white pieces of the ceiling. Because coated wooden gym floors are notorious for being extremely slippery when wet or otherwise contaminated, great care needs to be taken to keep these types of floors clean

The concrete hallway leading to the wooden gym floors were found to greatly increase in dry slip resistance when lightly dusted with a terry towel. Both areas that were tested showed this. This possibly indicates that these concrete hallways are a source of a high volume of dusty contaminants that may be getting dragged in and spread across the gym floors.

when in use. Large absorbent mats should be used outside (and inside) each door, and doors should remain closed to keep contaminants from blowing in. Mats should be cleaned regularly so that they are able to gather dust, moisture and any other contaminants from people's shoes before they spread these things onto the "slippery when wet or otherwise contaminated" flooring.

If gym classes have students running loops where they run from outside areas to the gym floor and back outside again, then we would expect the gym floor to get very dirty very quickly. These sorts of activities should be ceased, and every effort should be made to keep the gym floors clean. The ceiling material may be adding to the problem by dropping small pieces of itself onto the floor. The air ducts may also be spreading dust (or nearby construction dust) evenly over the area. The exact source of fine dust was not found during the testing, but a fine dust was found on the uncleaned half. Although it was not enough fine dust to create low pendulum test values, perhaps normal use would have generated much more dust in the area.
